System Test Results from LBL

K. Einsweiler, LBNL

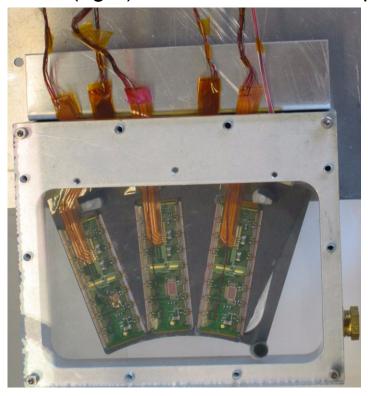
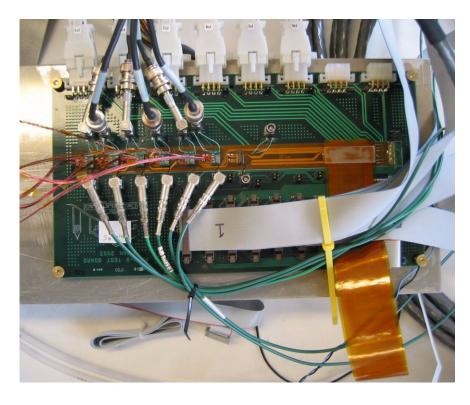
•Disk sector with six disk modules mounted (left) and connected to PP0 Support board (right) with all services for operation:

- Five of the disk modules are of the older "pigtailed" variety. LBL_15 and LBL_16 are the new "pigtail-less" variety.
- •The PP0 Support board provides connections for LV, HV, VCal, and the TPCC connections for readout.

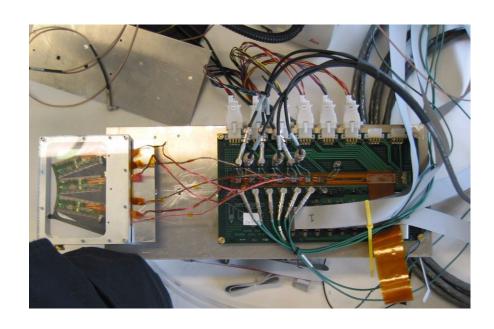
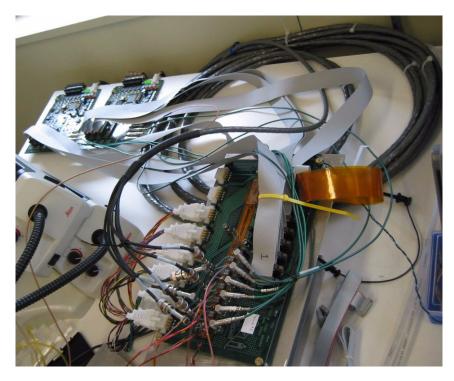
•Top three modules were read out out with one TPLL/TPCC. Bottom three modules were read out with a second TPLL/TPCC. However, both TPLL were in the same VME crate, and were read by the same PC. A Desktop Manager (Flash Desktop) was used to provide multiple desktops for running multiple copies (two) of TurboDAQ.

•Major limitation of this arrangement was that, due to the fact that TurboDAQ locks the GUI during scans, it was almost impossible to toggle back and forth between multiple copies of TurboDAQ. Note coiled 12m Type 2 cable in right photo.

- •In addition, even when both versions of TurboDAQ, competition for resources (both CPU and memory, and the VME interface) tended to eliminate any concurrency, and scan steps for the two modules would run in an "interleaved" mode.
- •Could do much better by allocating a second PC to the operation of the system test. Will do this for limited time for additional multi-module interference testing.
- •Of course, the next logical step is to begin trying to read out the disk sector with the ROD. This would provide truly independent operation for different modules at the same time, and would also support operations like multi-module source scans.

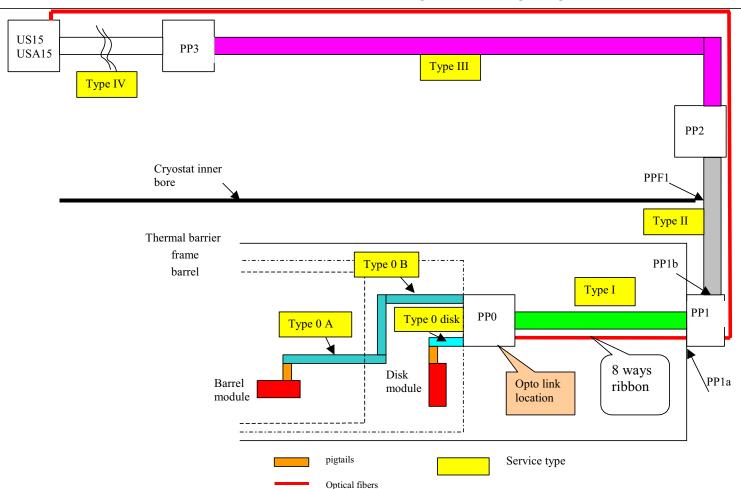
•Services setup is intended as a realistic electrical representation of the final services scheme, with reasonable wire lengths and gauges.

•PP0 is represented by the PP0 Support board. Type 1 and Type 2 cables are combined into a single 12m cable. Type 3 and Type 4 are combined into a single 140m cable.

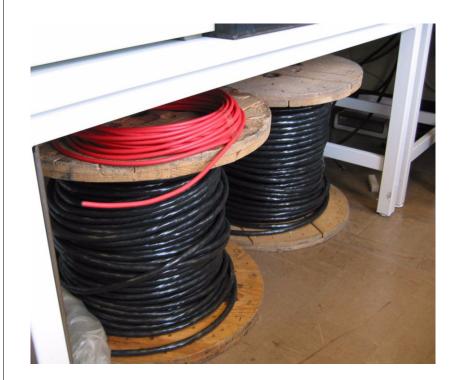
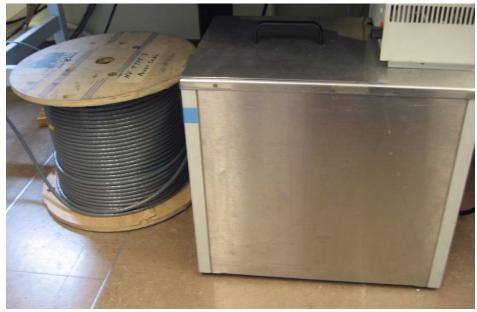
Cables:

- •On the left are two large rolls for 140m 6-pair AWG16 twisted-pair Type 3 cables (total mass about 100kg), connecting the Agilent LV supplies with the regulator board. One cable is for VDD and one cable is for VDDA.
- •On the right is a roll for 150m 6-pair AWG24 twisted-pair Type 3 cable for the ISEG HV supply. The chosen wire gauge was the smallest with an acceptable voltage rating.

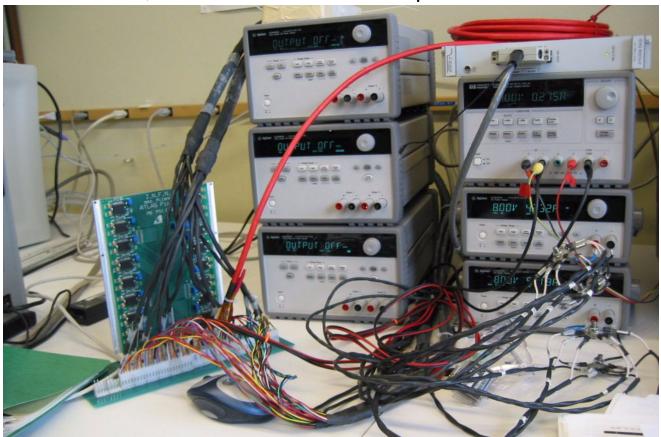
Regulators:

•Used first prototype ST regulator board from Milano. Regulators were operated in remote sense mode, but without "current compensation":

- •In this case, individual 8A supplies were used to power all six modules simultaneously, with one supply providing VDD, and the other VDDA.
- •Used 8V output voltage to conservatively guarantee correct voltage at module.

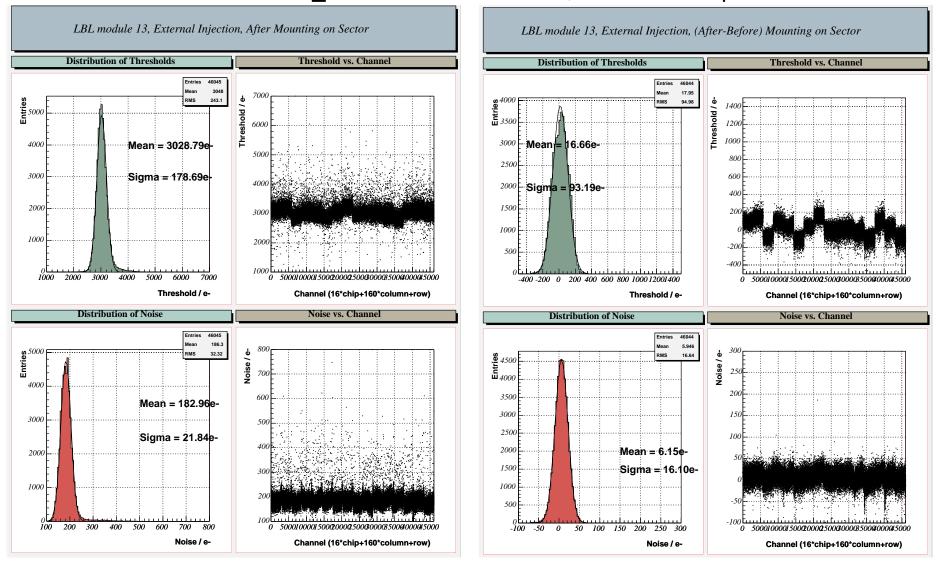
• Compare threshold scans made with single modules in the lab and with modules mounted on sector. LBL_13 shows similar noise, increased dispersion due to ΔT :

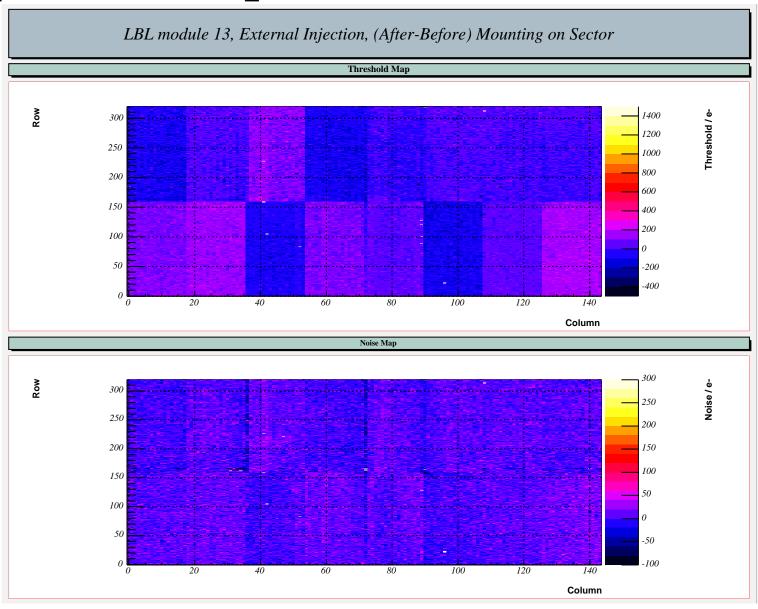
Map of differences for LBL_13:

•No significant differences seen.

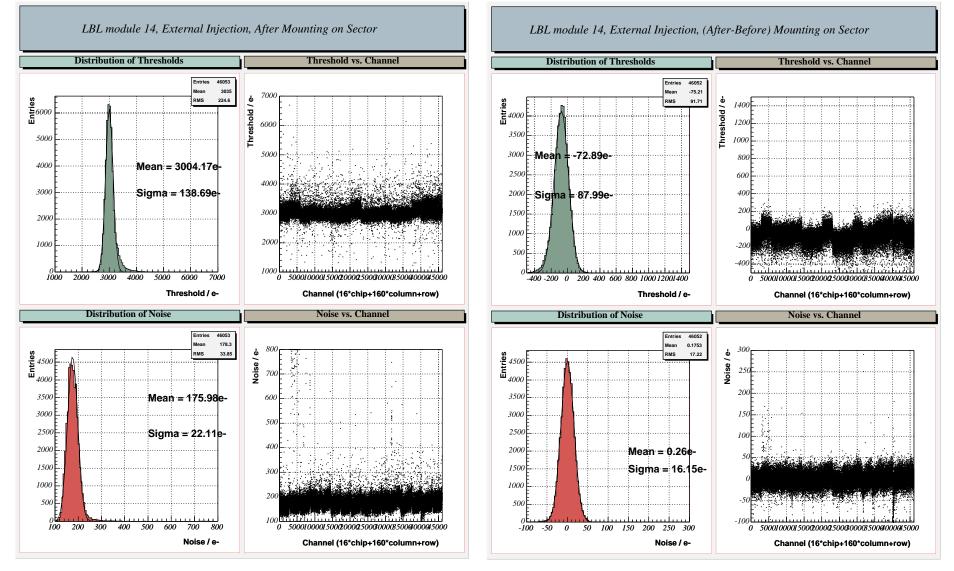
•Compare threshold scans made with single modules in the lab and with modules mounted on sector. LBL_14 shows similar noise, increased dispersion due to ΔT :

Only significant shift is in region of chip 1 ganged pixels, which showed very significant merging and poor behavior before mounting on sector.

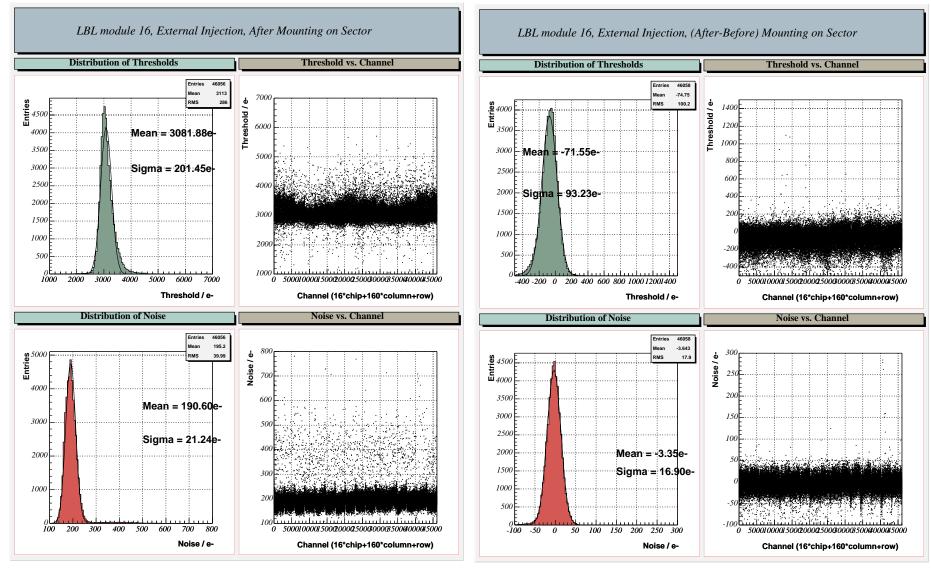
•Compare threshold scans made with single modules in the lab and with modules mounted on sector. LBL_16 shows similar noise, increased dispersion due to ΔT :

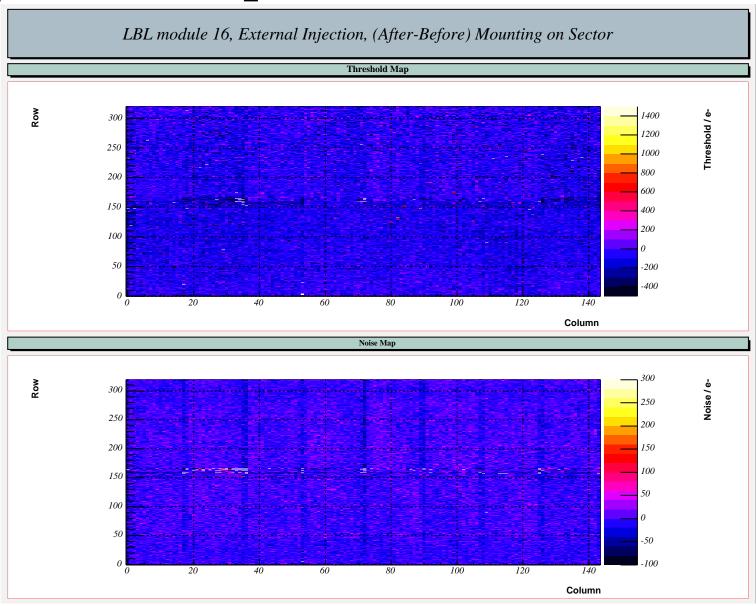
Map of differences for LBL_16:

•No significant differences observed.

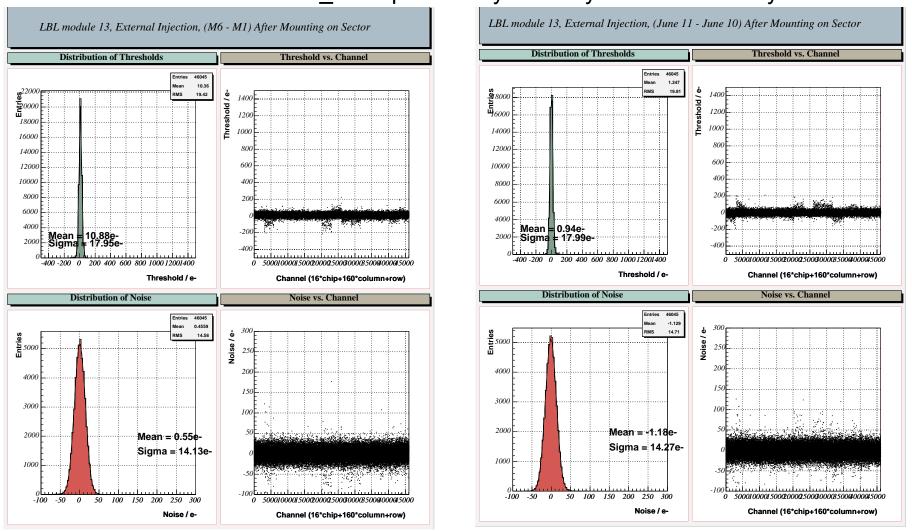
•Compare LBL_13 behavior on sector with multiplicity one and six. Also, compare two different scans of LBL_13 separated by one day to check stability.

•No significant changes observed. Note all three modules on bottom of sector strobed and triggered simultaneously during these scans.

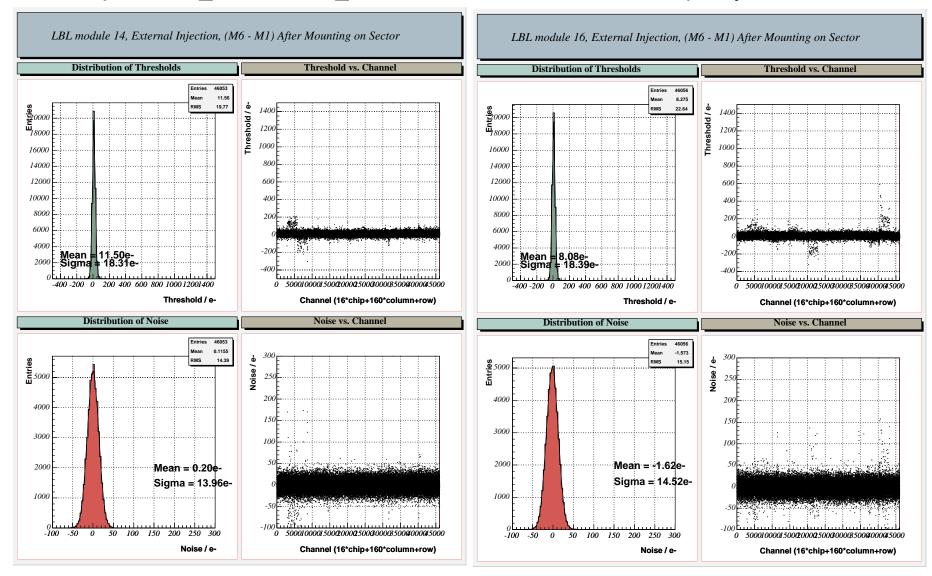
Compare LBL_14 and LBL_16 behavior on sector with multiplicity one and six.

•No significant changes observed. Note all three modules on bottom of sector strobed and triggered simultaneously during these scans.
